**National Highway
Traffic Safety
Administration**

Case Status Report

Case # 009

Accident Summary: Veh. 1 driving on 4-lane undivided roadway overreacted
to vehicle entering traffic lane swerved to right and contacted a wooden
utility pole. Airbag deployed causing driver 1 eyeglass frame to slice left
eyeglobe.

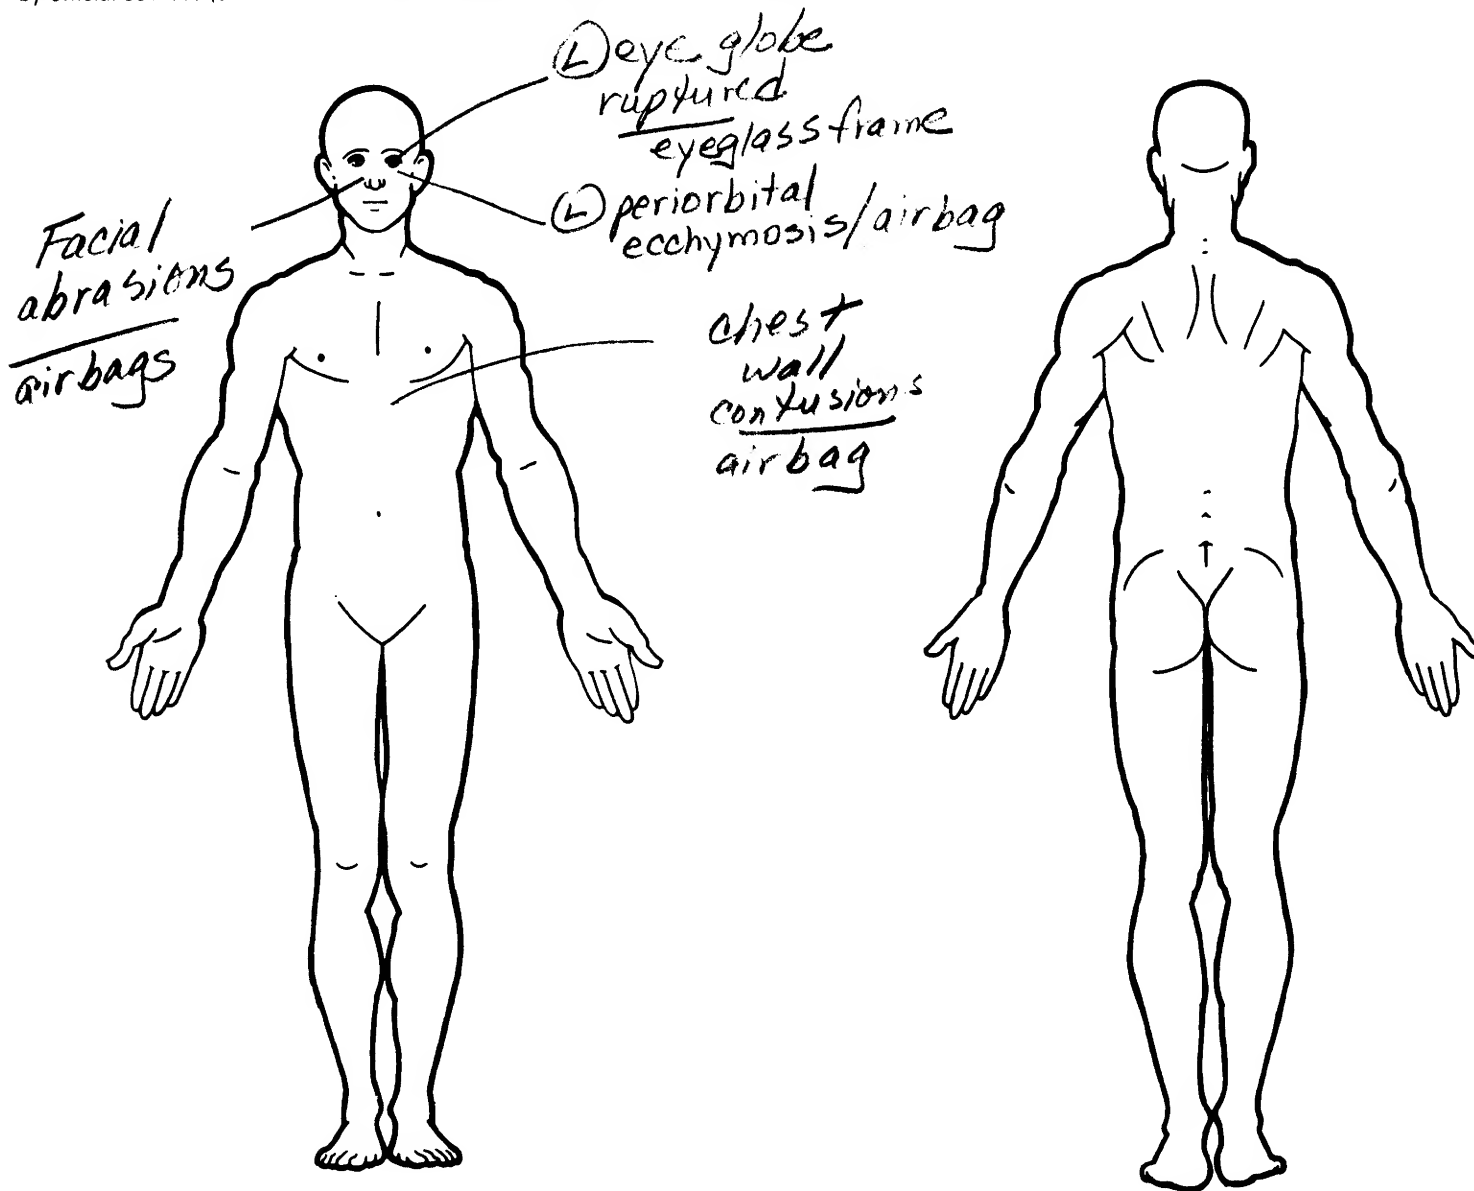
OFFICIAL INJURY DATA – SOFT TISSUE INJURIES

<u>AIS CODES</u>	<u>ICD-9</u>	<u>INJURIES</u>	<u>BODY CONTACTS</u>
FWAI 1	910.0	facial abrasions	deployed airbag
FLRO 2	871.2	left eye globe rupture	eyeglass frame via deployed airbag
CCCI 1	922.1	contusions over chest wall	deployed airbag
FLCO 1	921.0	left periorbital ecchymosis	deployed airbag

Indicate the *Location, Lesion, Detail* (size, depth, fracture type, head injury clinical signs and neurological deficits), and *Source* of all injuries indicated by official sources (or from PAR or other unofficial sources if medical records and interviewee data are unavailable.)

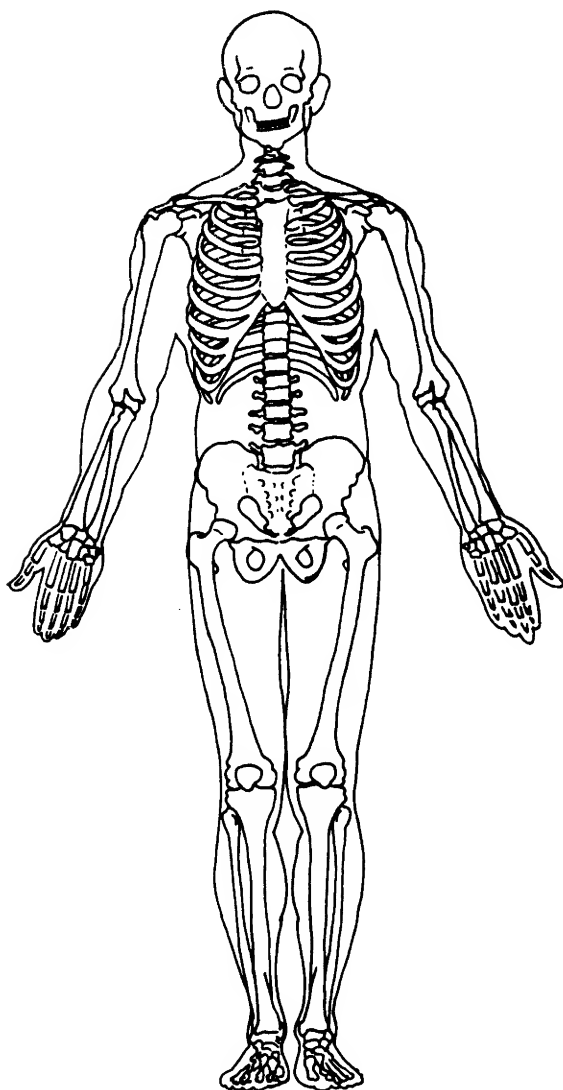
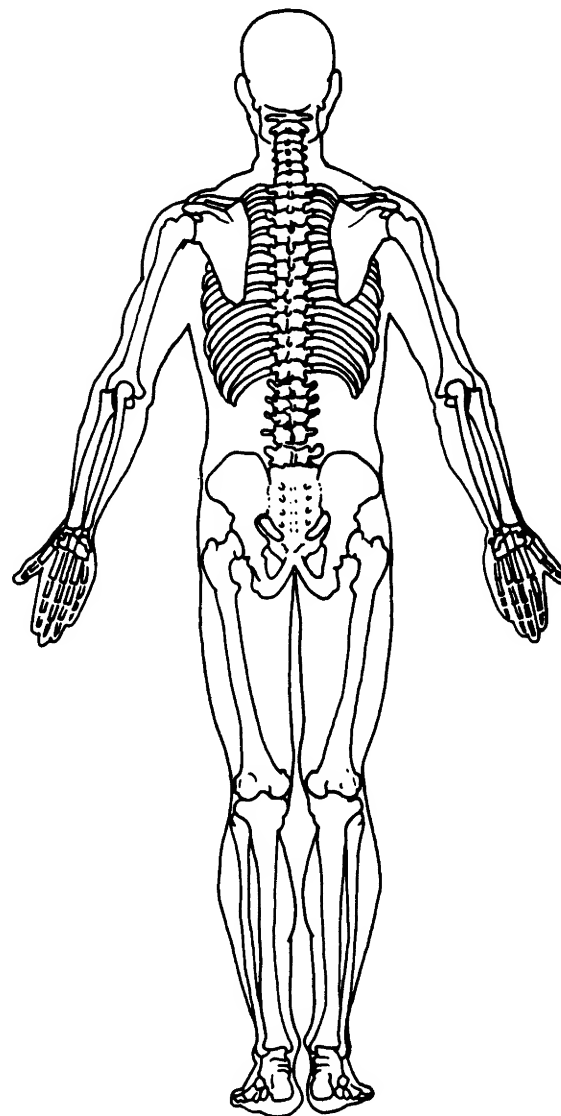
OFFICIAL INJURY DATA – SKELETAL INJURIES

Indicate the *Location, Lesion, Detail* (size, depth, fracture type, head injury clinical signs and neurological deficits), and *Source* of all injuries indicated by official sources (or from PAR or other unofficial sources if medical records and interviewee data are unavailable.)

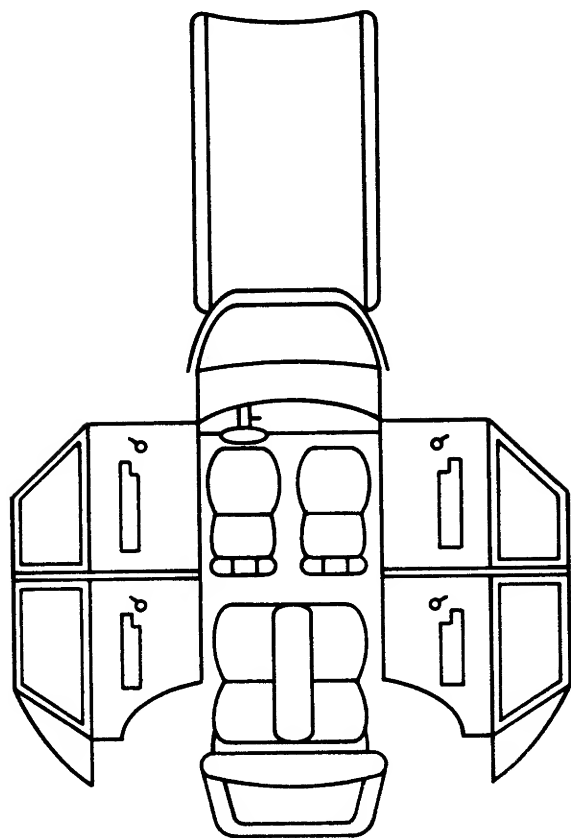
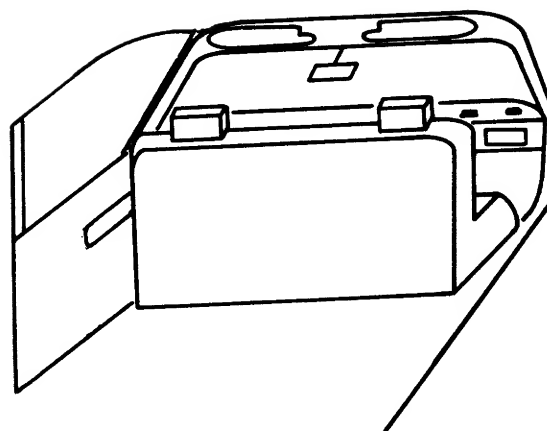
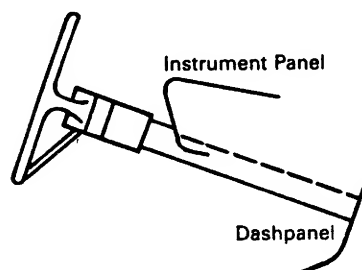
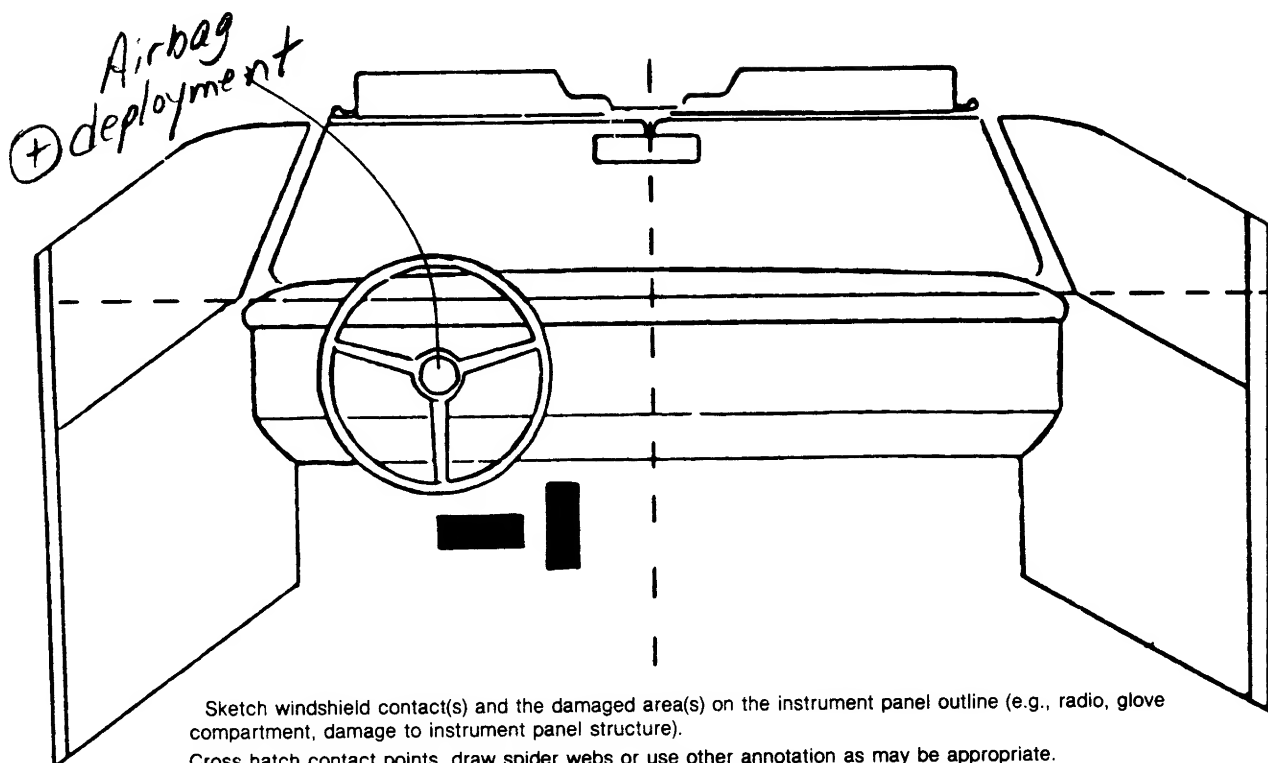
VEHICLE INTERIOR SKETCHES

Note area of ejection/entrapment

Sketch windshield contact(s) and the damaged area(s) on the instrument panel outline (e.g., radio, glove compartment, damage to instrument panel structure).

Cross hatch contact points, draw spider webs or use other annotation as may be appropriate.

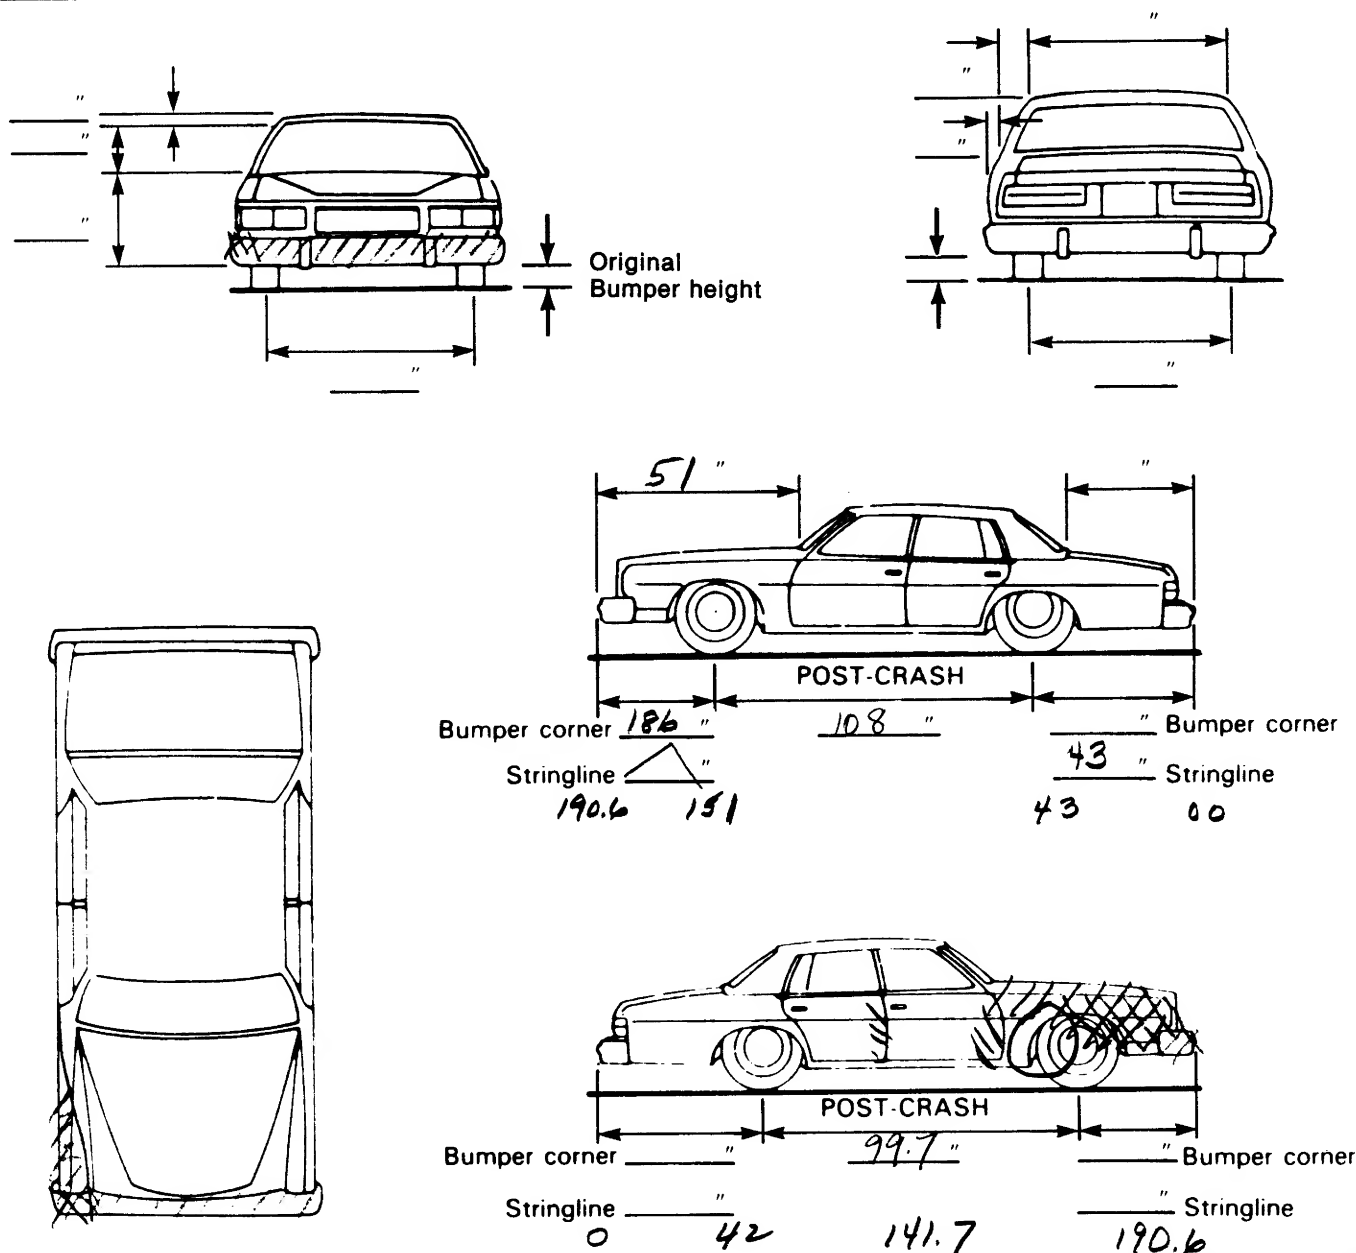
VEHICLE DAMAGE SKETCH

Specific Impact No.	Location of Direct Damage	Location of Field L	Location of Maximum Crush
1	Rt Front Corner	Full Front	C6

TIRE – WHEEL DAMAGE
 a. Rotation physically restricted
 RF 1
 LF 2
 RR 2
 LR 2
 b. Tire deflated
 RF 2
 LF 2
 RR 2
 LR 2
 (1) Yes (2) No (8) NA (9) Unk.

NOTES: Sketch new perimeter and cross hatch direct damage and single hatch induced damage on all views. Annotate observations which might be useful in reconstructing the accident (e.g., grass in tire bead, direction of striations, scuff on sidewall, etc.). If pulling trailer, sketch type of trailer and damage received on the back of this page.
 Annotate any damage caused by extrication such as component removal by torching, prying, or hydraulic shears.
